Comboni Catholic Hospital Sogakope, Rehabilitation of the Water supply Borehole protection Hat

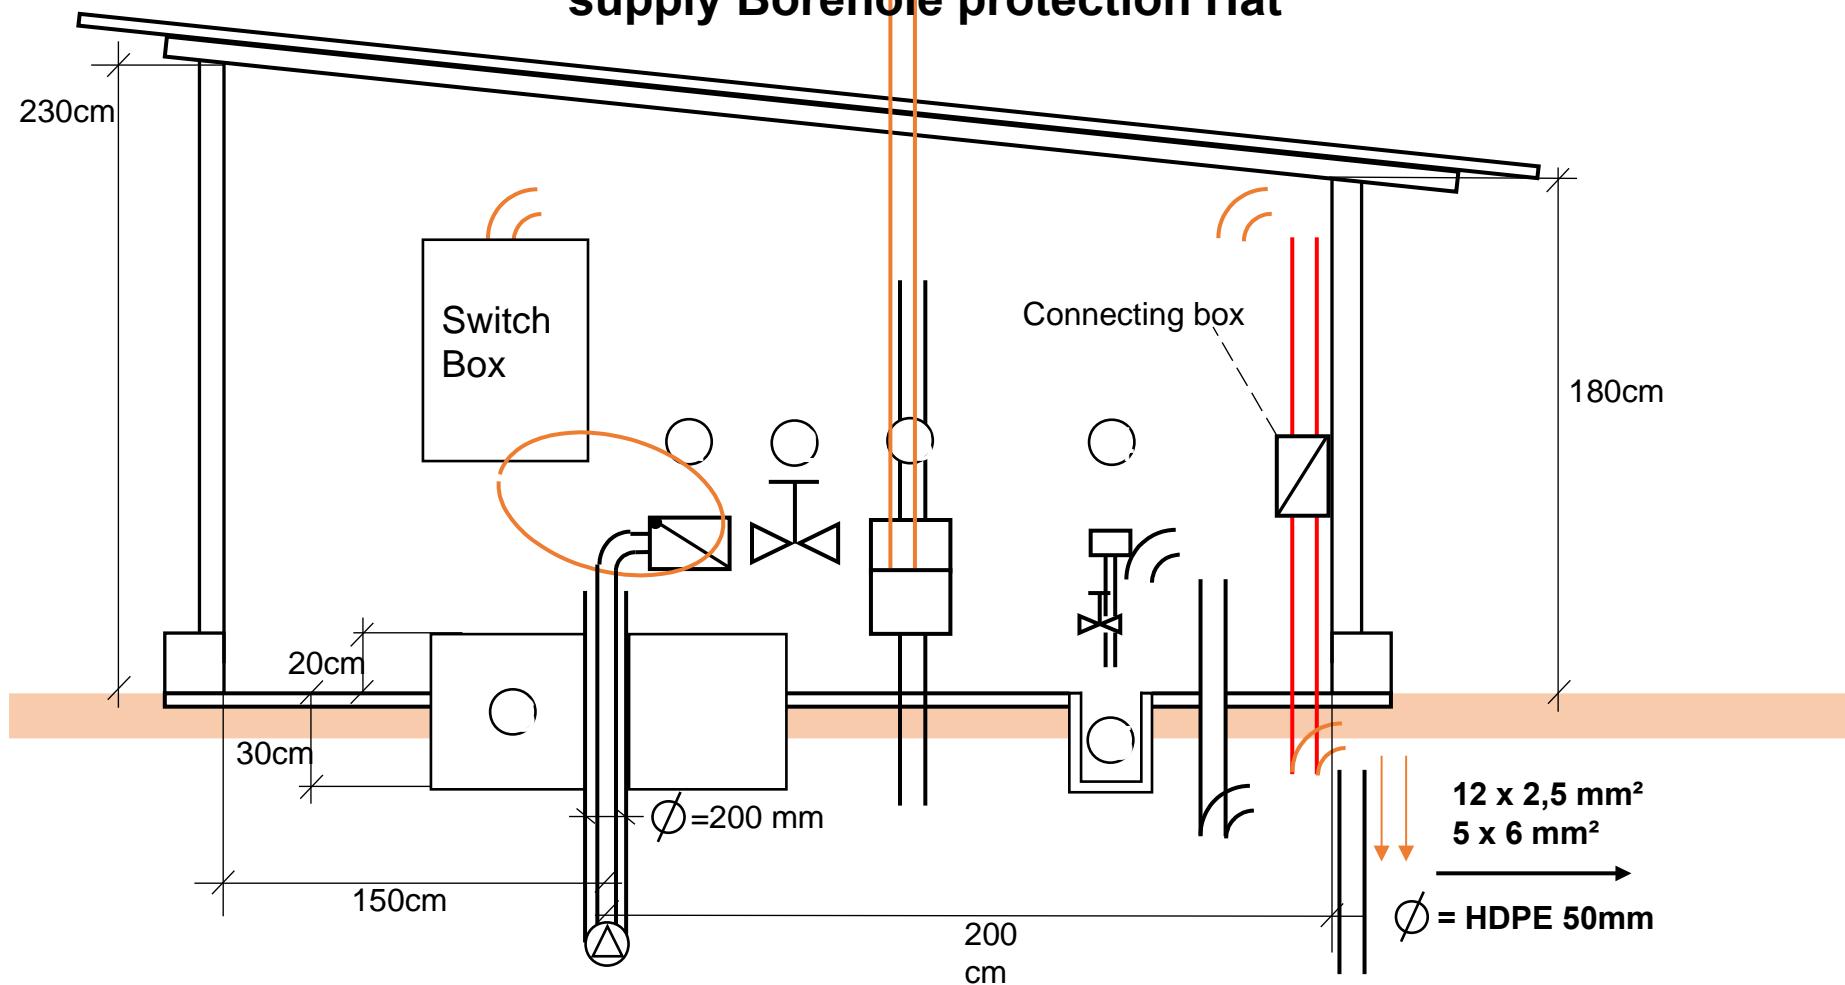
1. Non - return valve
2. Shut valve
3. Water - meter
4. Drain valve
5. Drain gutter
6. Well support
